Technical Bulletin #4

Study of the Effect of
Fitch Fuel Catalyst on Microbial Contaminated Diesel Fuel

TREATMENT OF BIO CONTAMINATED DIESEL FUEL WITH METAL ALLOY FUEL CATALYST

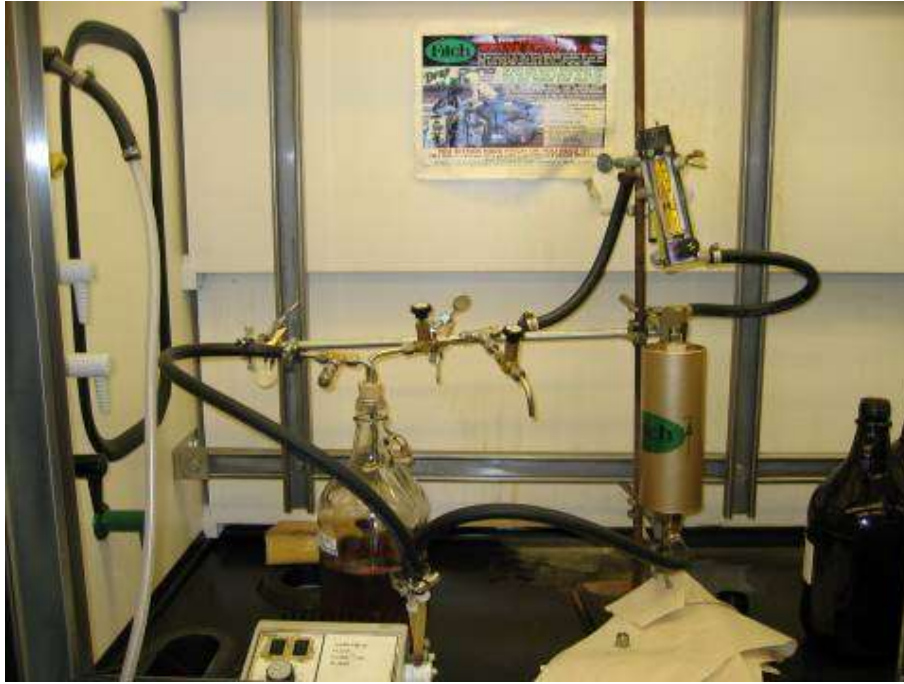
The treatment or exposure of contaminated spoiled diesel to the Fuel Catalyst was performed by incorporating the In Line FFC device into a re circulating system shown in Figure 1.

Circulating the fuel through the In Line FFC device treated the contaminated diesel. The initial exposure and treatment was for a two day period, 12 hours on followed by 12 hours off, simulating intermittent use such as a vehicle or generation equipment experiences in normal use. During operation the diesel fuel flow rate was maintained at 500 cc/min. The flow meter was calibrated manually. The contaminated diesel was subjected to continuous circulation and exposure to the In Line FFC device starting day 3 for an additional period of 4 days. The quality of the diesel was inspected by UV-Visible spectroscopy, by drawing from the return line. Fuel samples were drawn and inspected at 12-hour intervals during 96 hours of continuous operation.

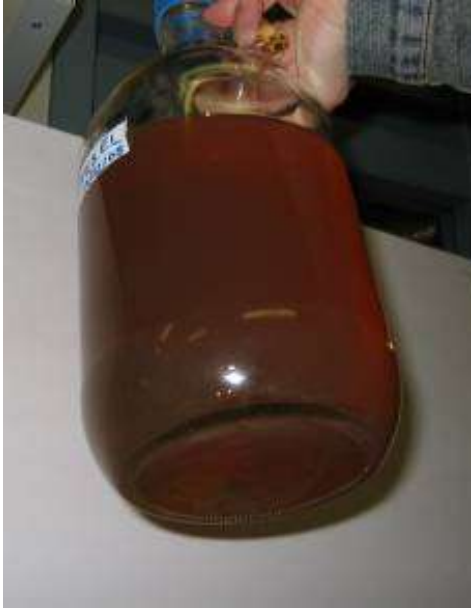
Figure 2. Microbial spoiled diesel #2

The spoiled diesel # 2 was very dirty and turbid. The Figures 2 and 3 show the appearance of the spoiled diesel after the 2-month incubation period before initiation of exposure to the fuel catalyst. The treated diesel appeared as in Figures 4 and 5

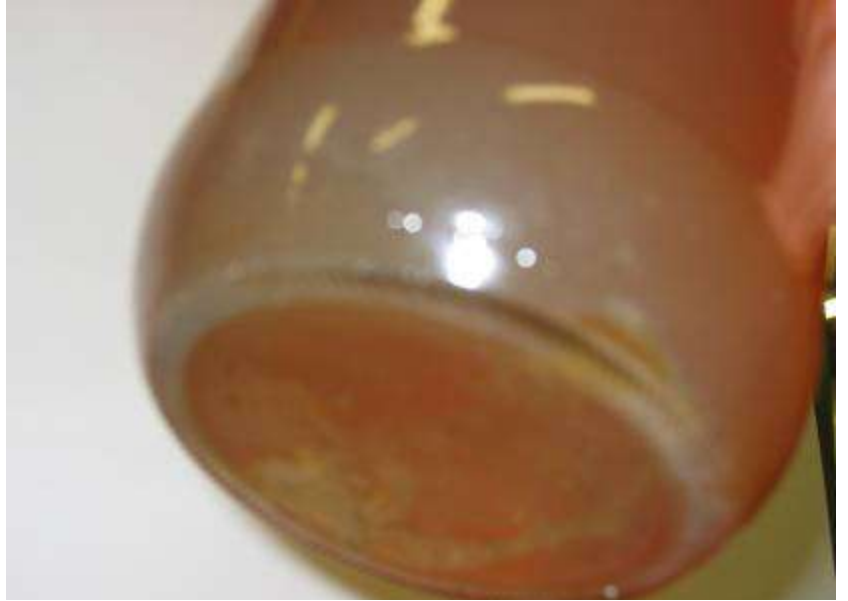
Figure 3. Close view of the microbial spoiled diesel

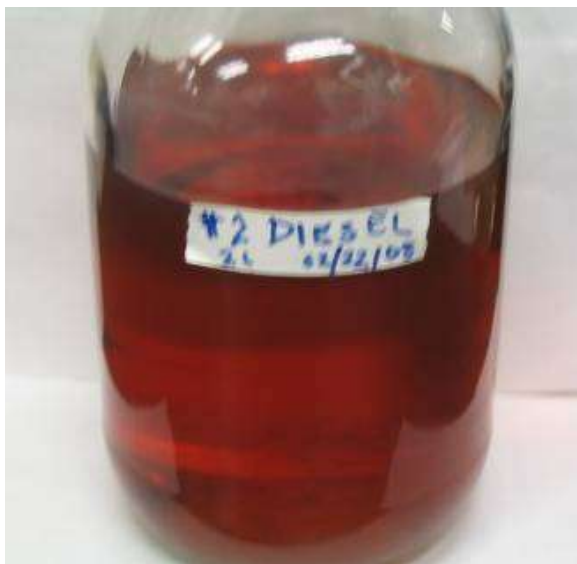
Figure 4. Close view of microbial spoiled diesel DF2 after treatment

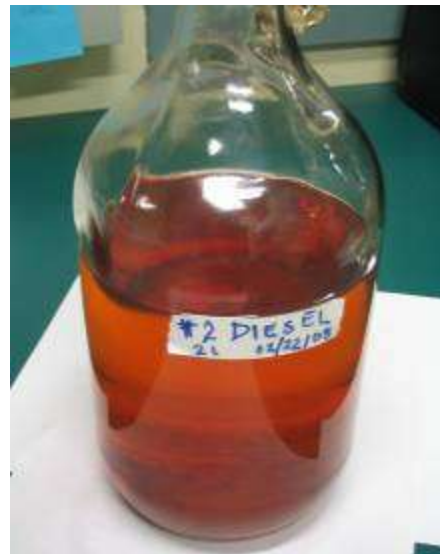
Figure 5. Microbial spoiled diesel DF2 after treatment

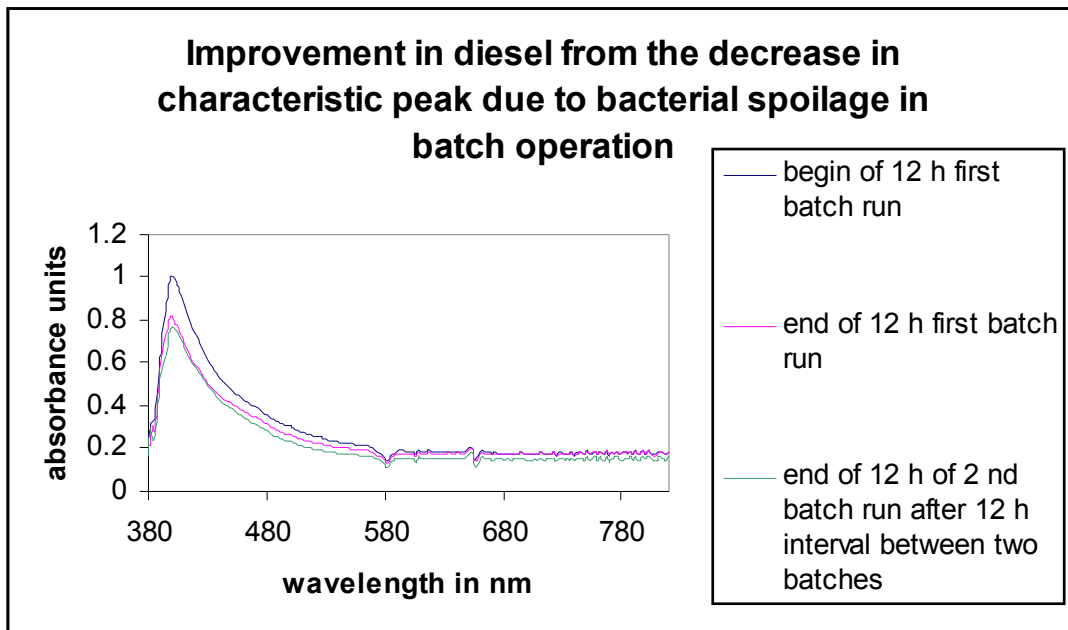
When the contaminated diesel was undergoing exposure to the In-Line FFC device during Day 1 and 2 of intermittent operations (12 h of circulation followed by 12 h of standby), the three UV-VIS samples depicted in Figure 8 were drawn at 12-hour intervals. The characteristic peak at ~ 400 nm decreased. The characteristic peak at 400 nm is the tool for measuring amount of diesel spoilage and bacterial contamination.

Figure 8. UV-VIS spectroscopy of treated diesel under intermittent operation.

The diesel was further analyzed by UV-VIS spectroscopy. The fresh diesel DF- 2 was taken as the blank for the UV-VIS. The UV-VIS spectroscopy from wavelength 380 nm to 820 nm shows only the extra peaks in spoiled diesel in relation to blank of fresh diesel DF 2. The results are shown in Figures 8 and 9. The peak at ~ 400 nm shows the spoiled diesel compared to the fresh diesel.
